2018 Tower Repair Project

NOVEMBER 15, 2017 – INFORMATION SESSION

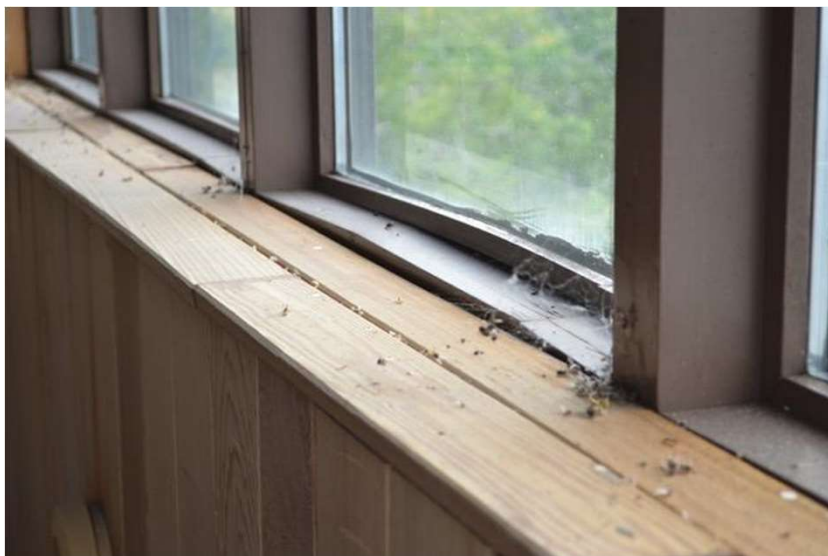
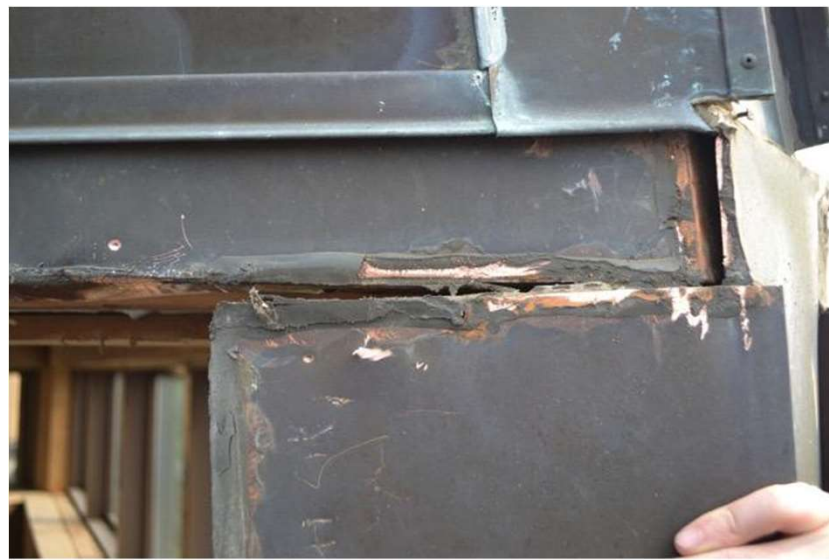
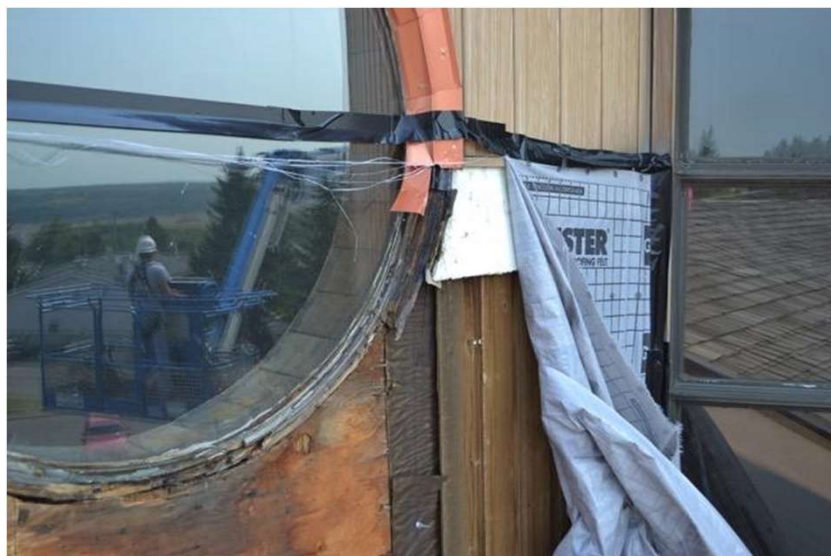
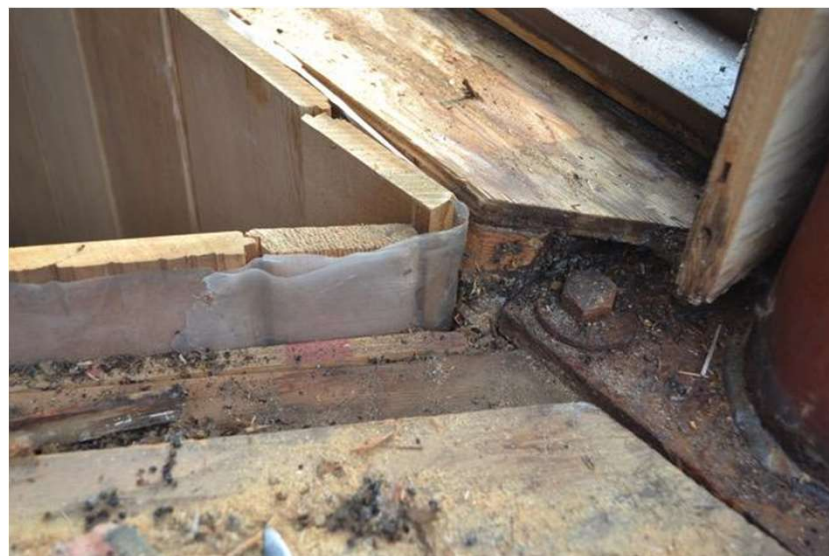
Main Towers

- Extensive damage to all tower windows and exterior claddings
- Poor workmanship on original construction and improper installation of aluminum siding coverings are the likely causes of a deteriorating building envelope.
- Current round window construction contributing to building envelope problem on one tower.

- Urgency confirmed – need to address building envelope issues to avoid long term structural damage and/or mould issues. **(Today's building envelope technology is much more advanced than in 1980)**
- Replace all tower windows and claddings.
- This requires the complete removal of all tower siding materials (aluminum siding, original cedar, building paper and sheathing) and refinish with similar aluminum siding or alternative material (e.g. Hardy board).
- Refinish/repair interior cedar panels with water damage.
- Secure tower crosses and upgrade the lightning arrest system.
- Repair bell tower damages to address imminent structural integrity risk.

- **Total Capital**
 - \$660K (includes consultant fees)
- **Main Towers (4) – repair building envelope**
 - Strip existing exterior siding and sheathing
 - Replace all tower windows
 - Replace exterior aluminum siding
 - Estimated cost \$605K
- **Bell Tower – isolate from weather**
 - Repair/seal existing source of weather damages
 - Repair damaged wood framing
 - Estimated cost \$30K
- **Scheduling**
 - May – August 2018
- **Impact during construction**
 - scaffolding will be erected on exterior of towers; no scaffolding in interior
 - most of work is external; any internal work done during weekdays
 - some of parking lot will be allotted for construction team
 - **Expectations – repair schedule should have minimal impact on church services and events.**

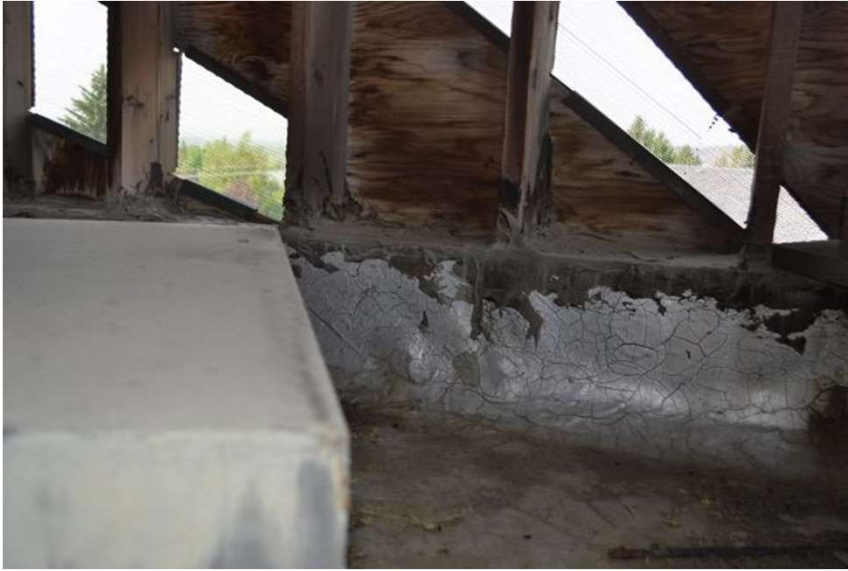
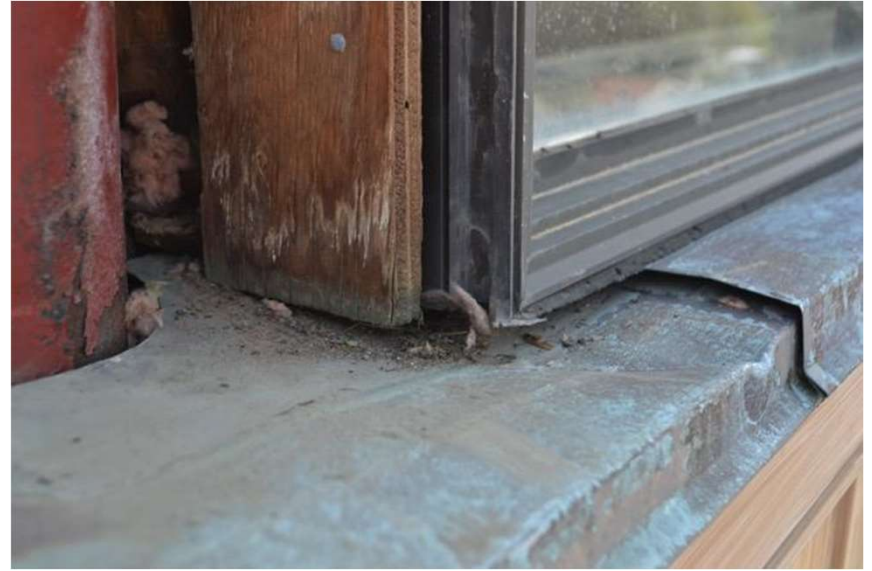
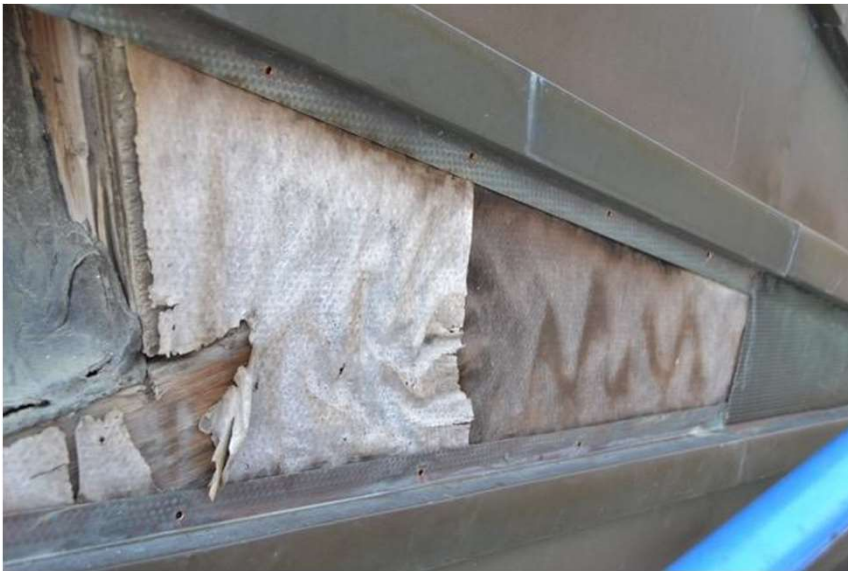
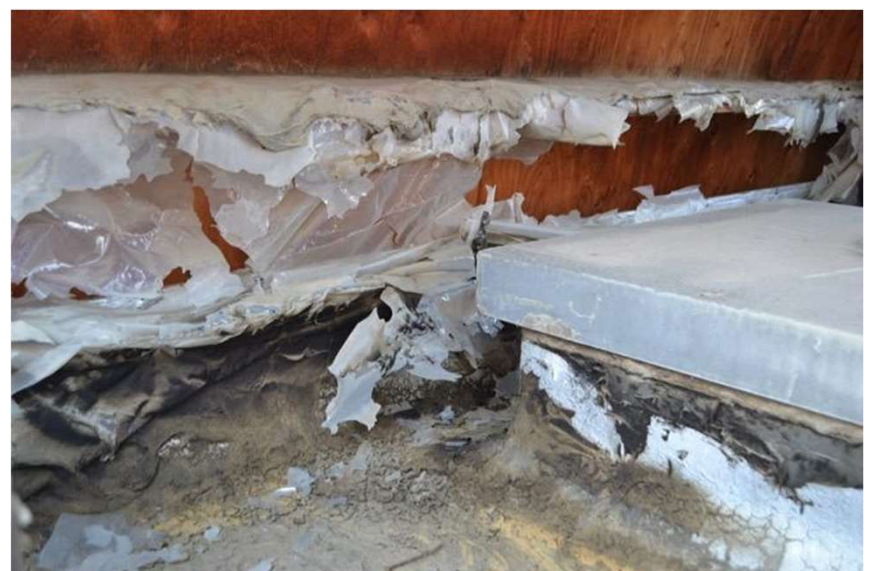
Bell Tower

- Water entry from screened panels in dome is causing significant damage to wood structural members
- Internal structure of dome needs extensive repair; tower below dome is OK
- Screened panels should be replaced with solid dome copper sheathing.
